**Flood Control Project Maintenance  
Levee Inspections**  
**LMA District Cover Sheet**  
**Spring 2017 Levee Inspection Results**

**Reclamation District No. 0017 Mossdale**

**Levee Inspection Report By Mile - Spring 2017**

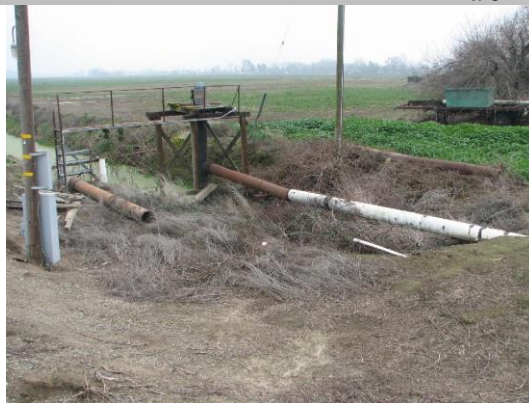
Photo 1 of 3 : UCIP\_SP\_2017\_40659\_72116.jpg

LM Start	3.63	Rating **	M	Issue No.	102
LM End	3.63	Issue Type +	En	Location *	WS
Category	Supplemental			GPS Latitude/Longitude	
				Start	End
Item	DWR UCIP Field Study			37.868657 °	37.868657 °
				-121.327383 °	-121.327383 °
DWR ID					
Comment Code					
Inspector Comment					
FS_ID:40659					
DS_ID:26					
EP_NO: 15109					
Repair Type: Non-Urgent					
Crossing Status: Found					
UCIP Comments: Erosion around siphon breaker on landward side					
recommend investigating potential leak.					
FIELD_STRUCT_DESC: 12 inch pipeline through levee. Invert of pipe					
is 4.0 feet below levee crown. Siphon breaker on landward shoulder.					
Pump in irrigation ditch 45 feet from landward toe. (Permit No. 15109-					
1990)					
FS Date: 2/4/2010

View of pipe section and pump station located on landward side.

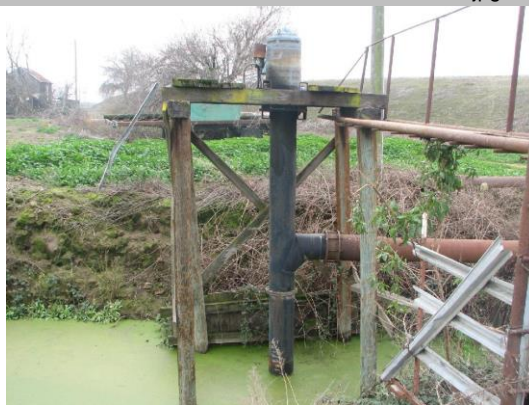
Photo 2 of 3 : UCIP\_SP\_2017\_40659\_72115.jpg

Pump station locate on landward side.

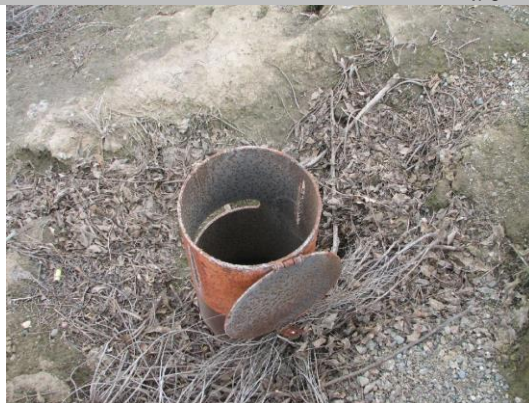
Photo 3 of 3 : UCIP\_SP\_2017\_40659\_72114.jpg

LM Start	3.63	Rating **	M	Issue No.	102 (cont)	
LM End	3.63	Issue Type +	En	Location *	WS	
Category	Supplemental			GPS Latitude/Longitude		
				Start	End	
Item	DWR UCIP Field Study			37.868657 °	37.868657 °	
				-121.327383 °	-121.327383 °	
DWR ID						
Comment Code						
Inspector Comment						
FS_ID:40659						
DS_ID:26						
EP_NO: 15109						
Repair Type: Non-Urgent						
Crossing Status: Found						
UCIP Comments: Erosion around siphon breaker on landward side						
recommend investigating potential leak.						
FIELD_STRUCT_DESC: 12 inch pipeline through levee. Invert of pipe						
is 4.0 feet below levee crown. Siphon breaker on landward shoulder.						
Pump in irrigation ditch 45 feet from landward toe. (Permit No. 15109-						
1990)						
FS Date: 2/4/2010

Siphon breaker located on landward slope.

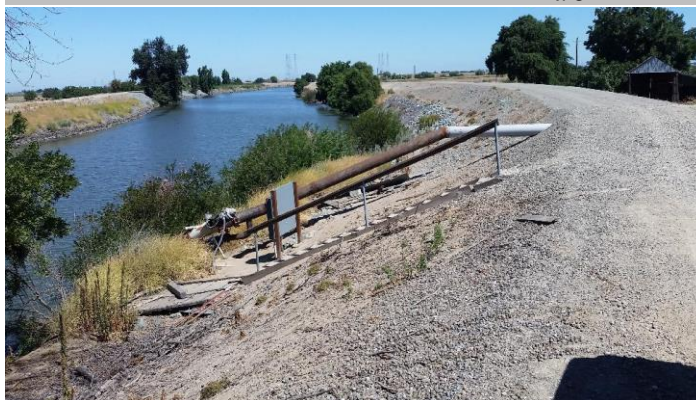
Photo 1 of 3 : UCIP\_SP\_2017\_50005\_75863.jpg

FS\_ID:50005  
 DS\_ID:25465  
 EP\_NO: N/A  
 Repair Type: Non-Urgent  
 Crossing Status: Found  
 UCIP Comments: 7/12/2016 Missing permit number and as-built drawings for this crossing. New pipe installed June 2016. According to Rick Toy, KSN-District Engineer, DCC Engineering is working with CVFPB to obtain permit for owner. Pipe replaces DS\_ID 27--pipe removed May 2016. (DWR UCIP - omagana)  
 FIELD\_STRUCT\_DESC: UNK-inch steel irrigation pipe through levee, X.XX feet below the crown. Slant pump is located on waterside (WS) slope, standpipe located 5 feet from LS toe. Concrete stairways with guardrail located on the WS. Two power poles (about 10 feet apart) located on landside (LS) toe. (Permit No. XXXXX, 2016 - XXXXXX)  
 FS Date: 7/12/2016

View of WS, photo taken looking downstream.

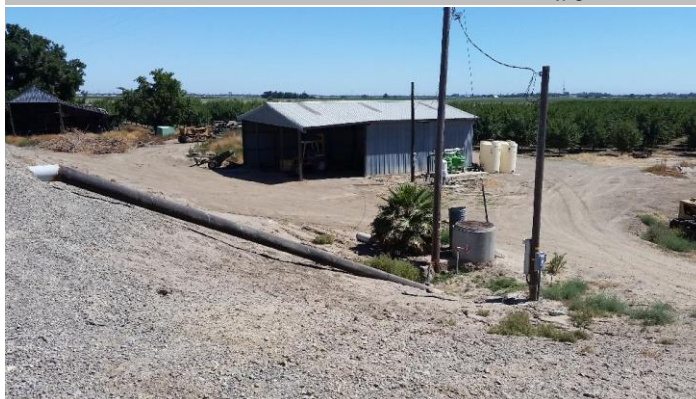
Photo 2 of 3 : UCIP\_SP\_2017\_50005\_75864.jpg

View of LS, photo taken looking downstream.

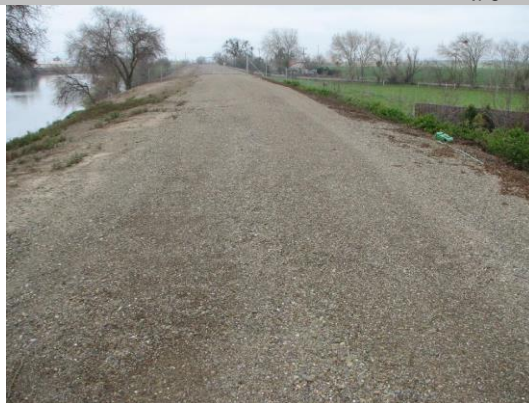
Photo 1 of 3 : UCIP\_SP\_2017\_43264\_72125.jpg

Comment Code					
Inspector Comment					
FS_ID:43264					
DS_ID:28					
EP_NO: 15111					
Repair Type: Non-Urgent					
Crossing Status: Found					
UCIP Comments: 2/4/15--Olivia 2010 Records from KSN show this crossing was removed based on the RD17 As-Built Pipe Crossing Stationing Reference, however when field verification was completed in this area a 2-inch pipe was found. This could be a different 2-inch pipe in nearby area. Need to coordinate with owner to determine permit issued for this crossing.2/4/10 Pipe is not continous. Need to coordinate with owner to determine status of crossing. If crossing is no longer in use owner will need to contact the CVFPB to comply with Title 23.					
FIELD_STRUCT_DESC: *REMOVED* 2 inch pipeline through levee. Invert of pipeline is 3.92 feet below levee crown. Siphon breaker on landward shoulder. Pump on waterward slope. Pipe extends beyond 10 feet of the landward toe. (Permit No. 15111-1990). This pipe was installed during the levee work approved under encroachment number 15014.

View of levee crown at crossing.

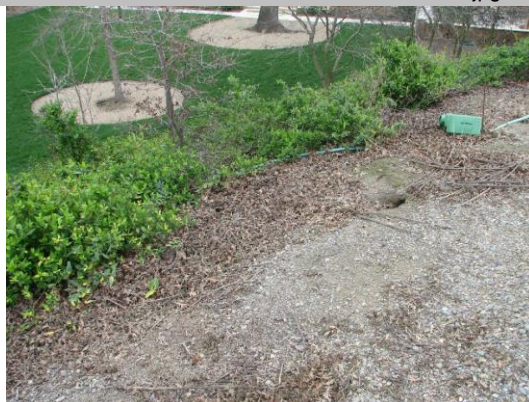
Photo 2 of 3 : UCIP\_SP\_2017\_43264\_72124.jpg

View of landward side.

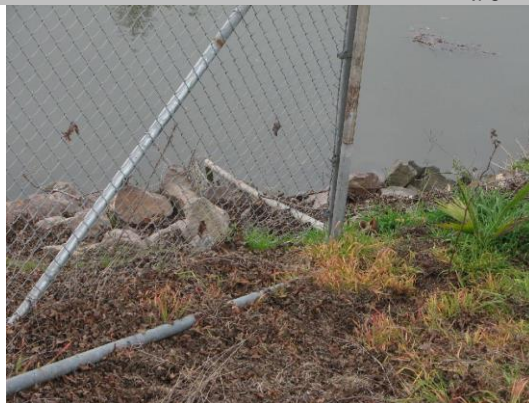
Photo 3 of 3 : UCIP\_SP\_2017\_43264\_72123.jpg

Item	DWR UCIP Field Study			37.863644 °		37.863644 °
				-121.320435 °		-121.320435 °
DWR ID						
Comment Code						
Inspector Comment						
FS_ID:43264 DS_ID:28 EP_NO: 15111 Repair Type: Non-Urgent Crossing Status: Found UCIP Comments: 2/4/15--Olivia 2010 Records from KSN show this crossing was removed based on the RD17 As-Built Pipe Crossing Stationing Reference, however when field verification was completed in this area a 2-inch pipe was found. This could be a different 2-inch pipe in nearby area. Need to coordinate with owner to determine permit issued for this crossing.2/4/10 Pipe is not continuous. Need to coordinate with owner to determine status of crossing. If crossing is no longer in use owner will need to contact the CVFPB to comply with Title 23. FIELD_STRUCT_DESC: *REMOVED* 2 inch pipeline through levee. Invert of pipeline is 3.92 feet below levee crown. Siphon breaker on landward shoulder. Pump on waterward slope. Pipe extends beyond 10 feet of the landward toe. (Permit No. 15111-1990). This pipe was installed during the levee work approved under encroachment number 15014. FS Date: 2/4/2010

View of crossing on waterward side.

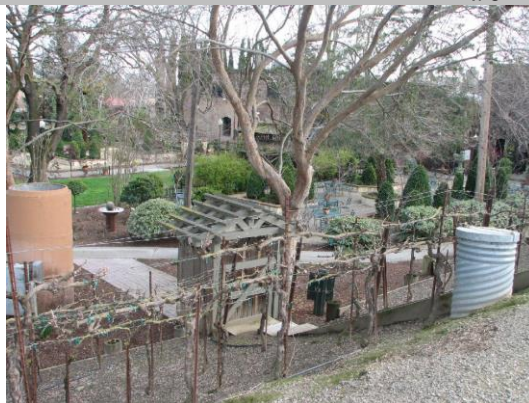
Photo 1 of 3 : UCIP\_SP\_2017\_40662\_72130.jpg

Comment Code					
Inspector Comment					
FS_ID:40662					
DS_ID:29					
EP_NO: 15112					
Repair Type: Non-Urgent					
Crossing Status: Found					
UCIP Comments: Need to coordinate with owner to determine status of crossing. If crossing is no longer in use owner will need to contact the CVFPB to comply with Title 23. Debris (pipe section) scattered on waterward side.					
FIELD_STRUCT_DESC: 10 inch diameter irrigation pipeline through levee. Invert of pipe is 4.12 feet below crown. Siphon breaker on landward shoulder. Pump on waterward berm, standpipe located 28 feet from the landward toe. (Permit No. 15112-1990). Stairway located on both waterward and landward slopes. This pipe was installed during the levee work approved under encroachment number 15014.					
FS Date: 2/4/2010

View of landward side.

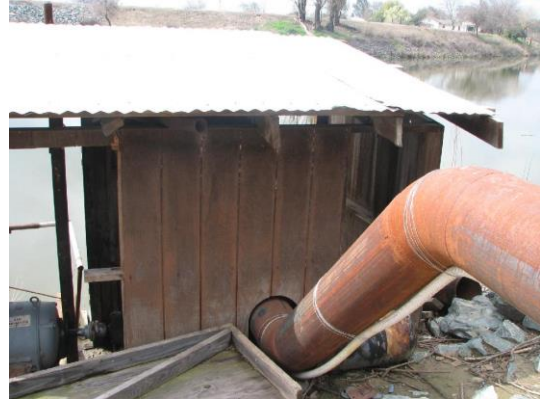
Photo 3 of 3 : UCIP\_SP\_2017\_40662\_72134.jpg

Comment Code					
Inspector Comment					
FS_ID:40662 DS_ID:29 EP_NO: 15112 Repair Type: Non-Urgent Crossing Status: Found UCIP Comments: Need to coordinate with owner to determine status of crossing. If crossing is no longer in use owner will need to contact the CVFPB to comply with Title 23. Debris (pipe section) scattered on waterward side. FIELD_STRUCT_DESC: 10 inch diameter irrigation pipeline through levee. Invert of pipe is 4.12 feet below crown. Siphon breaker on landward shoulder. Pump on waterward berm, standpipe located 28 feet from the landward toe. (Permit No. 15112-1990). Stairway located on both waterward and landward slopes. This pipe was installed during the levee work approved under encroachment number 15014. FS Date: 2/4/2010

Pipe through pump house located on waterward side.

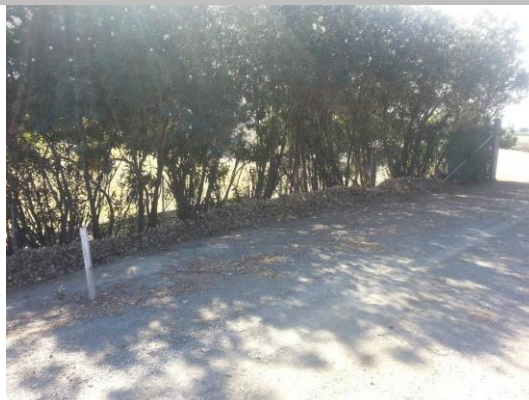
Photo 1 of 2 : SP\_2017\_RD0017\_304\_1\_20170316\_00001.jpg

LM Start	4.37	Rating **	A/W	Issue No.	1
LM End	4.39	Issue Type +	En	Location *	LS
Category	Earthen Levee			GPS Latitude/Longitude	
				Start	End
Item	Vegetation			37.861673 °	37.861370 °
				-121.320115 °	-121.320102 °
DWR ID	DWR_RD0017_02_s_2012_1				
Comment Code					
V6 : Landscaping					
Inspector Comment					
Oleander along fence line. LMA trimmed oleander along landside.

Looking south at trimmed oleanders on landward slope along fence.

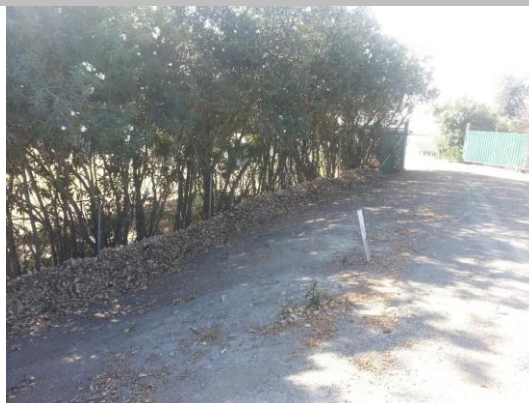
Photo 2 of 2 : SP\_2017\_RD0017\_304\_1\_20170316\_00002.jpg

Looking southwest at trimmed oleanders on landward slope along fence.

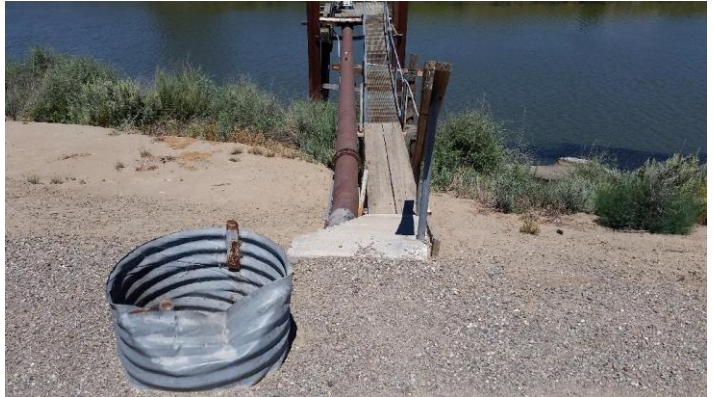
Photo 1 of 3 : UCIP\_SP\_2017\_49997\_75723.jpg

FS\_ID:49997  
DS\_ID:33  
EP\_NO: 15116  
Repair Type: Urgent  
Crossing Status: Found  
UCIP Comments: 7/12/2016 Same as last inspection--internal erosion on WS and LS slope slipping with visible head scarp. Internal erosion visible from WS where pipe daylights. LS slope slipping with visible head scarp approximately 6-inches. Need to coordinate with owner to address issue. Owner will need to work with DWR Inspector and CVFPB to comply with Title 23 requirements. Recommend internal integrity inspection of crossing to determine pipe condition through levee. (DWR UCIP - omagana)5/19/2015 Signs of internal erosion visible on waterward side where pipe daylights. Slope slumping visible on landward side where previous levee damage was present. Need to contact owner and KSN, LMA engineering firm, to coordinate potential issues with pipe. (DWR UCIP - omagana)2/04/2010 Pipe failure--internal erosion visible on waterward and landward side. Recommend LMA superintendent notify owner to stop using crossing to avoid further damage to levee slope. Owner will need to coordinate with DWR Inspector and CVFPB to address pipe failure per Title 23 requirements. (DWR UCIP - omagana)

View of WS.

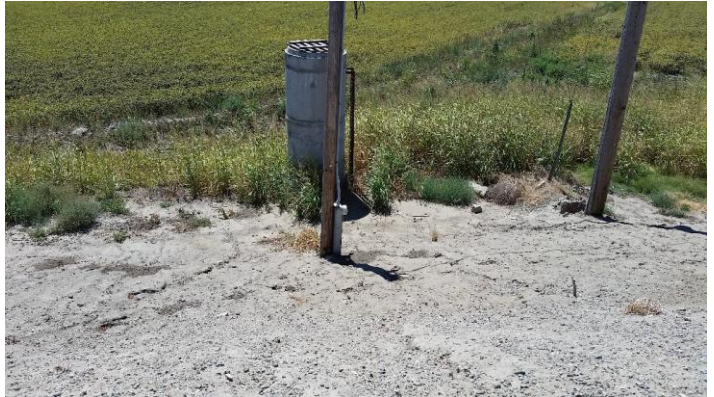
Photo 3 of 3 : UCIP\_SP\_2017\_49997\_75720.jpg

FS\_ID:49997  
DS\_ID:33  
EP\_NO: 15116  
Repair Type: Urgent  
Crossing Status: Found  
UCIP Comments: 7/12/2016 Same as last inspection--internal erosion on WS and LS slope slipping with visible head scarp. Internal erosion visible from WS where pipe daylights. LS slope slipping with visible head scarp approximately 6-inches. Need to coordinate with owner to address issue. Owner will need to work with DWR Inspector and CVFPB to comply with Title 23 requirements. Recommend internal integrity inspection of crossing to determine pipe condition through levee. (DWR UCIP - omagana)5/19/2015 Signs of internal erosion visible on waterward side where pipe daylights. Slope slumping visible on landward side where previous levee damage was present. Need to contact owner and KSN, LMA engineering firm, to coordinate potential issues with pipe. (DWR UCIP - omagana)2/04/2010 Pipe failure--internal erosion visible on waterward and landward side. Recommend LMA superintendent notify owner to stop using crossing to avoid further damage to levee slope. Owner will need to coordinate with DWR Inspector and CVFPB to address pipe failure per Title 23 requirements. (DWR UCIP - omagana)

View of LS.

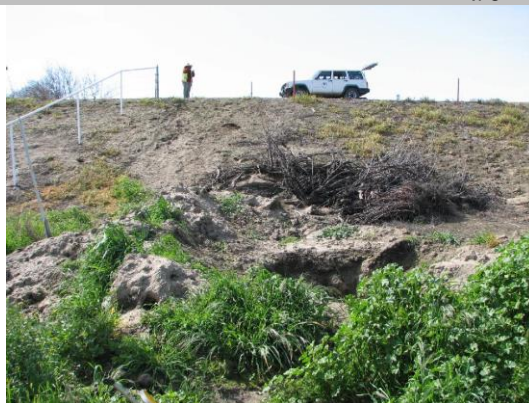
Photo 1 of 3 : UCIP\_SP\_2017\_49998\_72215.jpg

UCIP Comments: 7/12/2016 Crossing has been downgraded from Urgent to Non-Urgent--LS levee slope repaired. Levee slope was disturbed to repair leaky pipe--LS splice approximately 20-30 feet off the LS toe. Need to contact owner to determine if any documentation is available to support repair extent or internal integrity inspection of pipe through levee. (DWR UCIP - omagana)2/04/2010 Section of landward slope exposed--Need to contact owner to address cut on levee and determine status of crossing. Dense vegetation limits the inspector's visibility to identify signs of pipe failure (leaks) along the slope. Recommend removing vegetation along pipe alignment to conduct proper inspection of structure. (DWR UCIP - omagana)

View of LS.

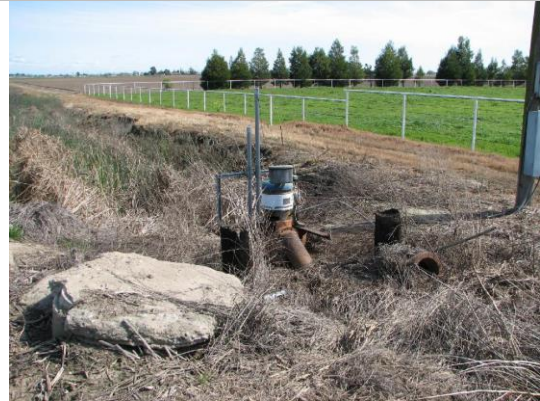
Photo 3 of 3 : UCIP\_SP\_2017\_49998\_72213.jpg

FS\_ID:49998  
DS\_ID:34  
EP\_NO: 15117  
Repair Type: Non-Urgent  
Crossing Status: Found  
UCIP Comments: 7/12/2016 Crossing has been downgraded from Urgent to Non-Urgent--LS levee slope repaired. Levee slope was disturbed to repair leaky pipe--LS splice approximately 20-30 feet off the LS toe. Need to contact owner to determine if any documentation is available to support repair extent or internal integrity inspection of pipe through levee. (DWR UCIP - omagana)2/04/2010 Section of landward slope exposed--Need to contact owner to address cut on levee and determine status of crossing. Dense vegetation limits the inspector's visibility to identify signs of pipe failure (leaks) along the slope. Recommend removing vegetation along pipe alignment to conduct proper inspection of structure. (DWR UCIP - omagana)  
FIELD\_STRUCT\_DESC: 10-inch steel irrigation pipe through levee, 3.43 feet below the levee crown. Siphon breaker is located on the waterside (WS) shoulder. Pump is located approximately 100 feet from the landside (LS) toe. Ramp is located on the LS slope. Pipe was installed as part of the re-shaping of RD17 project levees in 1989. The re-shaping of the levees was to increase levee elevations and provide freeboard above 100-year stages in both the San Joaquin River and French Camp Slough; work was authorized and documented under Permit No. 15014. (Permit No. 15117, 1989 - Rio Blanco Ranch, Inc.; levee re-shaping authorized under Permit No. 15014, 1989 - Reclamation District 17) [Additional Reference(s): DWR Levee Log, 1981 and 2003]

Pump station located on LS toe.

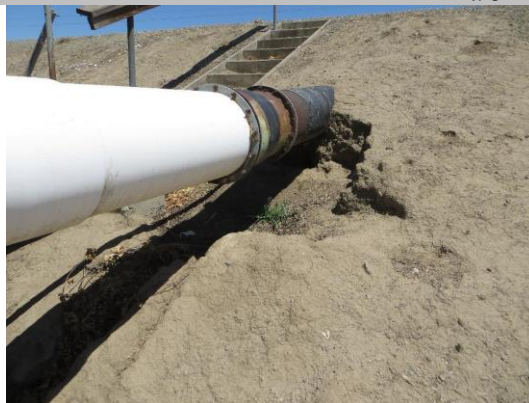
Photo 1 of 3 : UCIP\_SP\_2017\_45998\_74483.jpg

FS\_ID:45998  
DS\_ID:35  
EP\_NO: 15118  
Repair Type: Non-Urgent  
Crossing Status: Found  
UCIP Comments: 05/19/2015 Erosion is still present on waterward side--wet soil along pipe alignment (where pipe section is exposed). Burrow activity is also present at this location. Recommend contacting owner to address burrow activity. 02/04/2010 Erosion visible on waterward side visible at pipe daylight. Need to contact owner to address potential pipe failure. Need to determine status of crossing.  
FIELD\_STRUCT\_DESC: 14 inch diameter irrigation pipeline through levee. Invert of pipe is 4.49 feet below levee crown. Siphon breaker on landward shoulder. Pump on platform in channel, wooden walkway extends from pump platform to waterward slope, concrete stairway extends from walkway to waterward shoulder and a standpipe is located 2 feet from the landward toe. (Permit No. 15118-1989)  
FS Date: 5/19/2015

(2015) View of waterward side--erosion at pipe daylight.

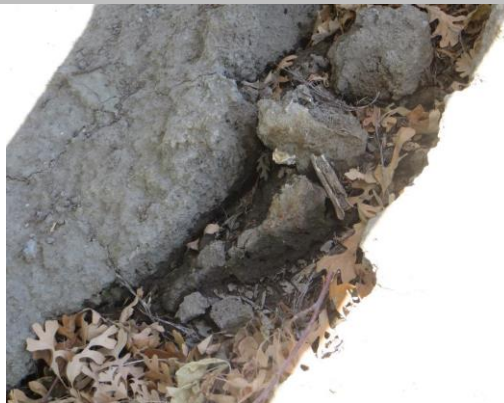
Photo 2 of 3 : UCIP\_SP\_2017\_45998\_74485.jpg

(2015) Wet ground along pipe alignment on waterward side.

Comment Code					
Inspector Comment					
FS_ID:45998 DS_ID:35 EP_NO: 15118 Repair Type: Non-Urgent Crossing Status: Found UCIP Comments: 05/19/2015 Erosion is still present on waterward side--wet soil along pipe alignment (where pipe seciton is exposed). Burrow activity is also present at this location. Recommend contacting owner to address burrow activity. 02/04/2010 Erosion visible on waterward side visible at pipe daylight. Need to contact owner to address potential pipe failure. Need to determine status of crossing. FIELD_STRUCT_DESC: 14 inch diameter irrigation pipeline through levee. Invert of pipe is 4.49 feet below levee crown. Siphon breaker on landward shoulder. Pump on platform in channel, wooden walkway extends from pump platform to waterward slope, concrete stairway extends from walkway to waterward shoulder and a standpipe is located 2 feet from the landward toe. (Permit No. 15118-1989) FS Date: 5/19/2015

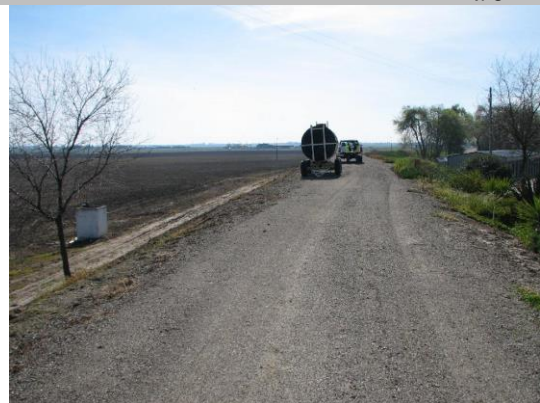
Photo 1 of 3 : UCIP\_SP\_2017\_40669\_72239.jpg

LM Start	5.41	Rating **	M	Issue No.	110
LM End	5.41	Issue Type +	En	Location *	LS
Category	Supplemental			GPS Latitude/Longitude	
				Start	End
Item	DWR UCIP Field Study			37.851319 °	37.851319 °
				-121.321336 °	-121.321336 °
DWR ID					
Comment Code					
Inspector Comment					
FS_ID:40669					
DS_ID:36					
EP_NO: 15119					
Repair Type: Non-Urgent					
Crossing Status: Found					
UCIP Comments: Need to contact owner to determine status.					
FIELD_STRUCT_DESC: 16 inch diameter pipe through levee. Invert of pipe is 5.11 feet below levee crown. Slant pump on riverbank, standpipe located 30 feet from the landward toe. Ramp on waterward slope. (Permit No. 15119-1990). This pipe was installed during the levee work approved under encroachment number 15014.					
FS Date: 2/4/2010

Overview of levee crown at crossing.

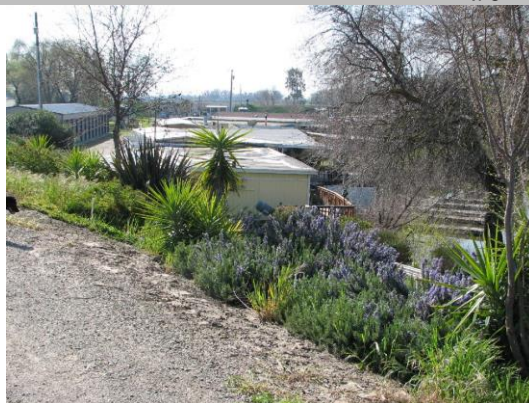
Photo 2 of 3 : UCIP\_SP\_2017\_40669\_72238.jpg

View of waterward side.

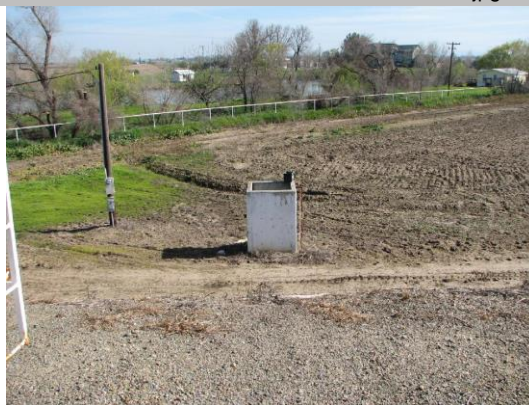
Photo 3 of 3 : UCIP\_SP\_2017\_40669\_72237.jpg

Distribution box located on landward side.

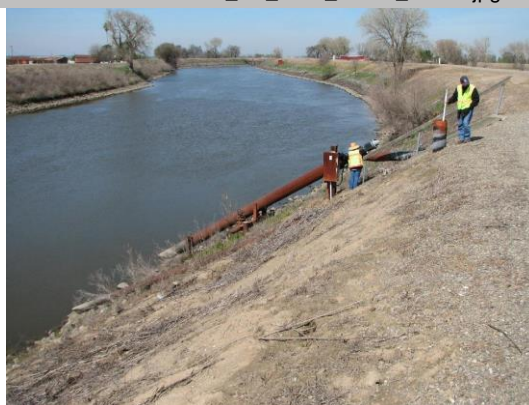
Photo 1 of 3 : UCIP\_SP\_2017\_40672\_72270.jpg

LM Start	6.14	Rating **	M	Issue No.	111
LM End	6.14	Issue Type +	En	Location *	LS
Category	Supplemental			GPS Latitude/Longitude	
				Start	End
Item	DWR UCIP Field Study			37.844392 °	37.844392 °
				-121.320753 °	-121.320753 °
DWR ID					
Comment Code					
Inspector Comment					
FS_ID:40672 DS_ID:38 EP_NO: 15121 Repair Type: Non-Urgent Crossing Status: Found UCIP Comments: Pipe section at waterward toe is missing wall. Need to coordinate with owner to determine integrity of pipe section through levee. This crossing is a good candidate for video inspection to determine internal condition of pipe. FIELD_STRUCT_DESC: 2 of 2. 10 inch steel stormdrain through the levee 4.0-feet below crown. (Permit No. 15121-1991) This pipe was installed during the levee work approved under encroachment number 15014. FS Date: 2/4/2010

View of pipe section on waterward side.

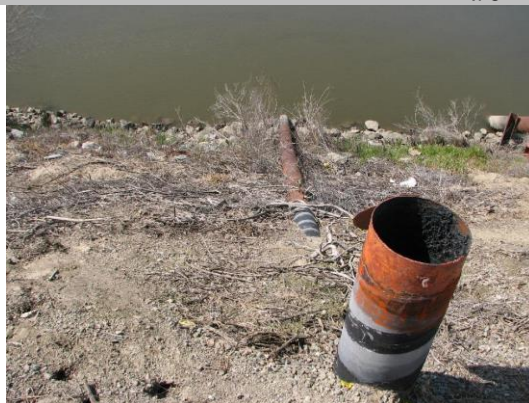
Photo 2 of 3 : UCIP\_SP\_2017\_40672\_72267.jpg

View of waterward side.

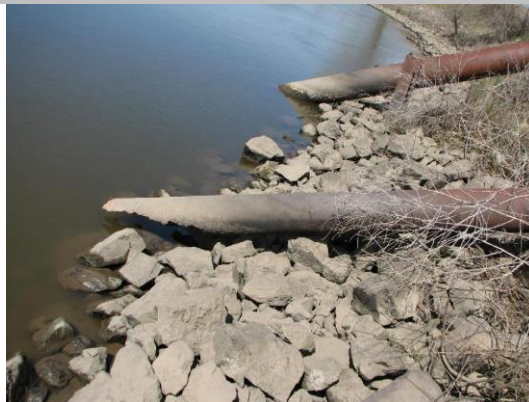
Photo 3 of 3 : UCIP\_SP\_2017\_40672\_72271.jpg

Pipe section inside wall has completely corroded--wall missing.

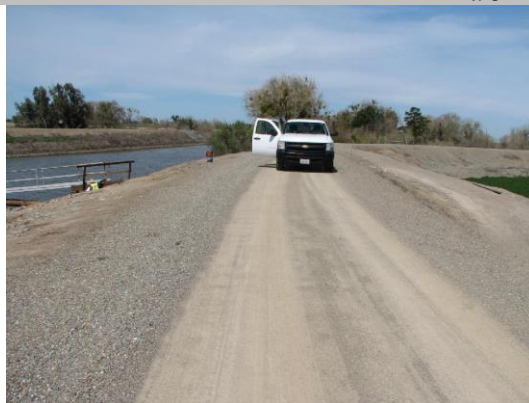
Photo 1 of 3 : UCIP\_SP\_2017\_40677\_72289.jpg

Comment Code					
Inspector Comment					
FS_ID:40677					
DS_ID:40					
EP_NO: 15123					
Repair Type: Non-Urgent					
Crossing Status: Found					
UCIP Comments: Landowner mentioned power line was stolen crossing was non-functional during inspection. Potential erosion underneath walkway--need to confirm lose soil. Need to contact owner to determine status of crossing. If crossing is no longer used need to coordinate with CVFPB for proper abandonment.					
FIELD_STRUCT_DESC: 16 inch diameter pipe through levee. Invert of pipe is 4.03 feet below the levee crown. Siphon breaker on waterward shoulder. Ramp on platform in channel, walkway from pump platform to waterward slope, standpipe located at landward berm toe. (Permit No. 15123-1989)					
FS Date: 2/4/2010

View of levee crown at crossing.

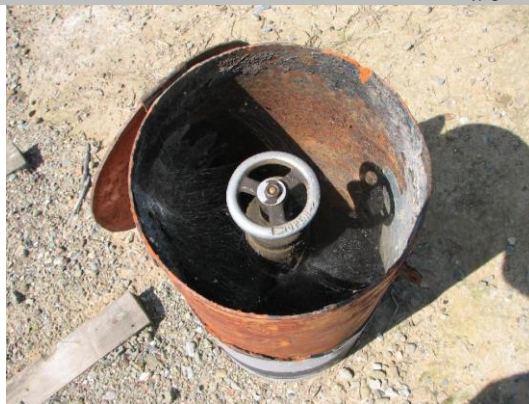
Photo 2 of 3 : UCIP\_SP\_2017\_40677\_72294.jpg

Siphon breaker located on waterward side.

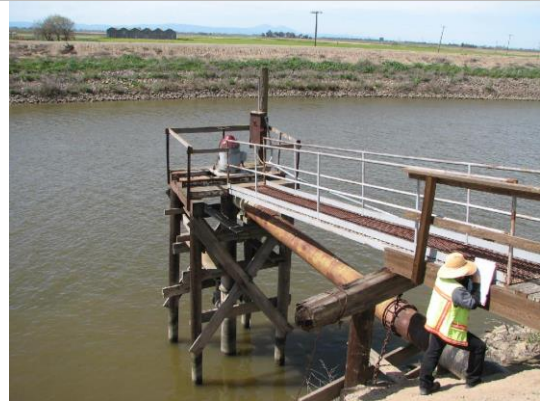
Photo 3 of 3 : UCIP\_SP\_2017\_40677\_72292.jpg

View of waterward side.

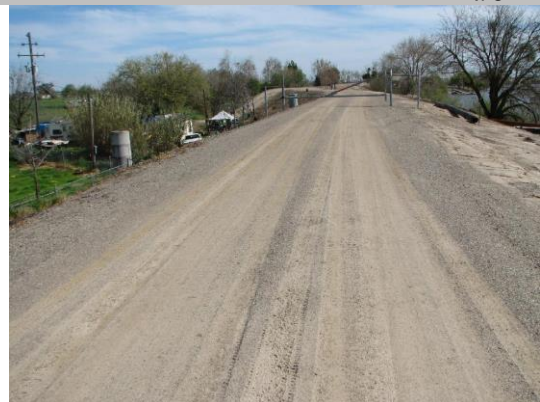
Photo 1 of 3 : UCIP\_SP\_2017\_40679\_72307.jpg

LM Start	7.17	Rating **	M	Issue No.	113
LM End	7.17	Issue Type +	En	Location *	LS
Category	Supplemental			GPS Latitude/Longitude	
				Start	End
Item	DWR UCIP Field Study			37.833426 °	37.833426 °
				-121.313023 °	-121.313023 °
DWR ID					
Comment Code					
Inspector Comment					
FS_ID:40679					
DS_ID:42					
EP_NO: 15077					
Repair Type: Non-Urgent					
Crossing Status: Found					
UCIP Comments: Surface erosion on waterward slope. Abandoned pipe section left on waterward slope. Need to contact owner to obtain additional information about crossing.					
FIELD_STRUCT_DESC: 12 inch diameter irrigation pipeline through levee. Invert of pipe 3.67 feet below levee crown. Siphon breaker on landward shoulder. Pump on platform in channel, walkway from pump platform to waterward shoulder. Standpipe located 15 feet from the landward toe. (Permit No. 15077-1989)					
FS Date: 2/4/2010

Overview of levee crown at crossing.

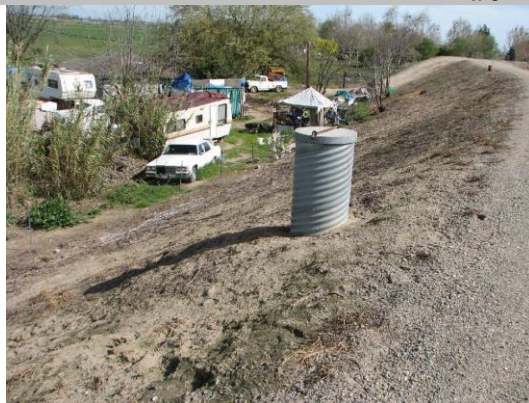
Photo 2 of 3 : UCIP\_SP\_2017\_40679\_72306.jpg

CMP riser located on landward slope.

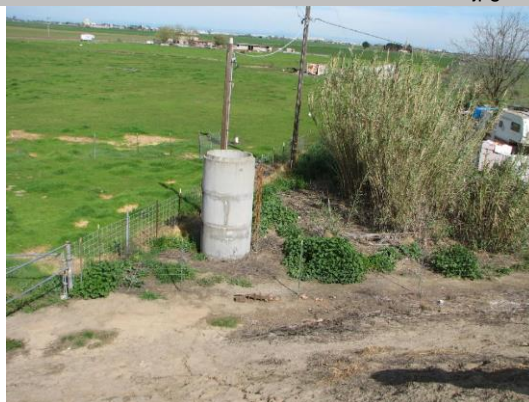
Photo 3 of 3 : UCIP\_SP\_2017\_40679\_72305.jpg

Standpipe visible on landward toe.

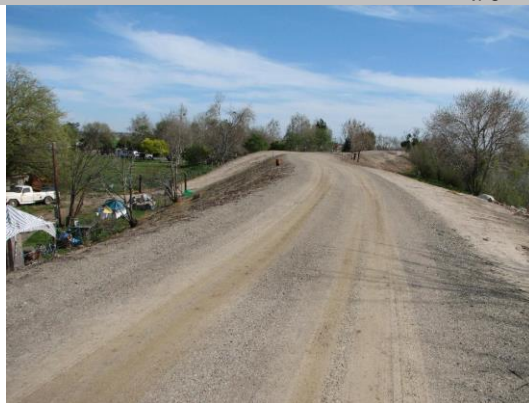
Photo 1 of 3 : UCIP\_SP\_2017\_40680\_72314.jpg

LM Start	7.20	Rating **	M	Issue No.	114
LM End	7.20	Issue Type +	En	Location *	LS
Category	Supplemental			GPS Latitude/Longitude	
				Start	End
Item	DWR UCIP Field Study			37.833088 °	37.833088 °
				-121.312676 °	-121.312676 °
DWR ID					
Comment Code					
Inspector Comment					
FS_ID:40680 DS_ID:43 EP_NO: 15078 Repair Type: Non-Urgent Crossing Status: Found UCIP Comments: Crossing is non-functional recommend contacting owner to determine status of crossing. If crossing is no longer used need to coordinate with CVFPB for proper abandonment. FIELD_STRUCT_DESC: 4 inch diameter pipeline through levee. Invert of pipe is 3.22 feet below levee crown. Siphon breaker on landward shoulder. Pump on waterward berm. (Permit No. 15078-1989) FS Date: 2/4/2010

Overview of levee crown at crossing.

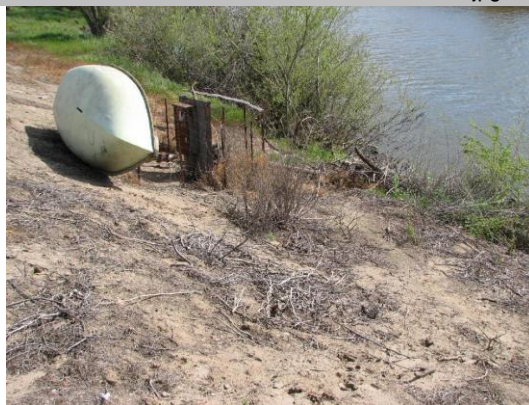
Photo 2 of 3 : UCIP\_SP\_2017\_40680\_72313.jpg

Abandoned boat protecting pump station located on waterward side.

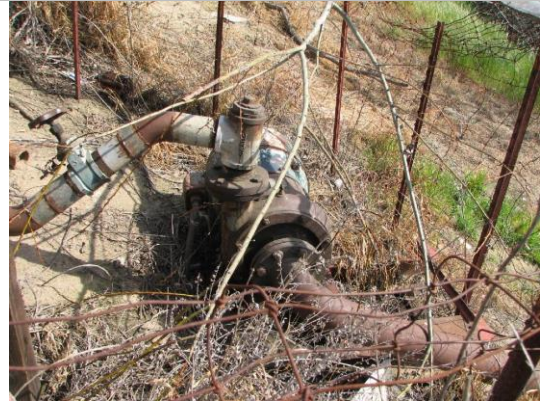
Photo 3 of 3 : UCIP\_SP\_2017\_40680\_72316.jpg

Motor located on waterward slope.

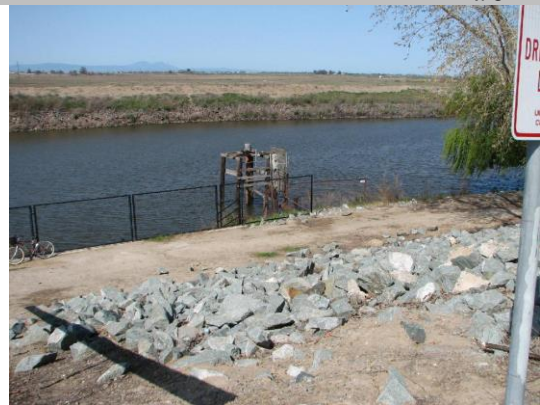
Photo 1 of 3 : UCIP\_SP\_2017\_40681\_72325.jpg

Comment Code					
Inspector Comment					
FS_ID:40681					
DS_ID:44					
EP_NO: 15079					
Repair Type: Non-Urgent					
Crossing Status: Found					
UCIP Comments: If crossing is no longer in use owner will need to coordinate with DWR inspector and CVFPB to remove according to Title 23 requirements. Unable to determine if crossing is in use.					
FIELD_STRUCT_DESC: 14 inch pipeline through levee. Invert of pipe is 4.28 feet below levee crown. Siphon breaker on waterward shoulder. Pump on platform in channel, walkway from pump platform to the top of the riverbank, standpipe located 12 feet from landward tee. (Permit No. 15079-1990)					
FS Date: 2/4/2010

View of waterward side.

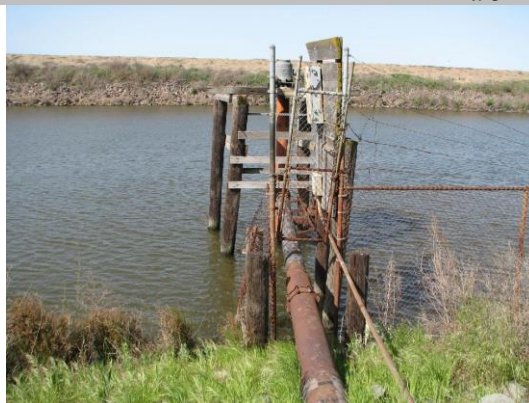
Photo 2 of 3 : UCIP\_SP\_2017\_40681\_72328.jpg

Pipe, pump, and platform located on waterward side.

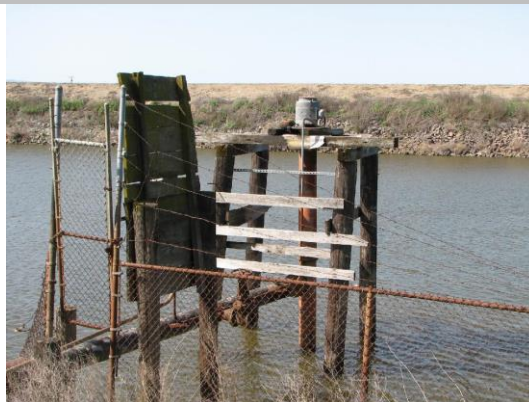
Photo 3 of 3 : UCIP\_SP\_2017\_40681\_72330.jpg

Pump station fenced off on waterward side.

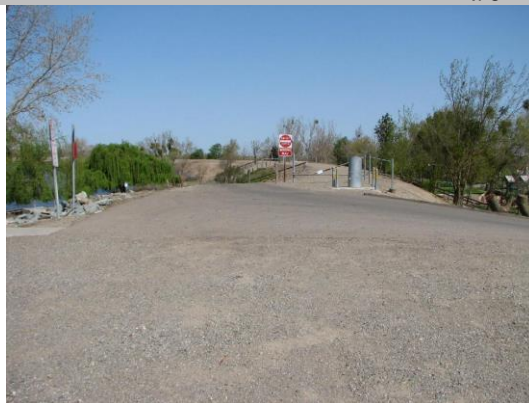
Photo 1 of 3 : UCIP\_SP\_2017\_40682\_72322.jpg

LM Start	7.44	Rating **	M	Issue No.	116
LM End	7.44	Issue Type +	En	Location *	LS
Category	Supplemental			GPS Latitude/Longitude	
				Start	End
Item	DWR UCIP Field Study			37.830115 °	37.830115 °
				-121.310908 °	-121.310908 °
DWR ID					
Comment Code					
Inspector Comment					
FS_ID:40682					
DS_ID:99					
EP_NO: 17643					
Repair Type: Non-Urgent					
Crossing Status: Found					
UCIP Comments: Need to coordinate with owner to determine when the other 3 crossings will become online.					
FIELD_STRUCT_DESC: 36-inch steel lined and coated stormdrain pipe through the levee 2-feet below the crown. Concrete headwall on WS toe and a tidal flex valve on outlet of pipe. Structure was designed for 4 crossings however only 1 crossing is active (Permit No. 17643, 2005).					
FS Date: 2/4/2010

Overview of levee crown at crossing.

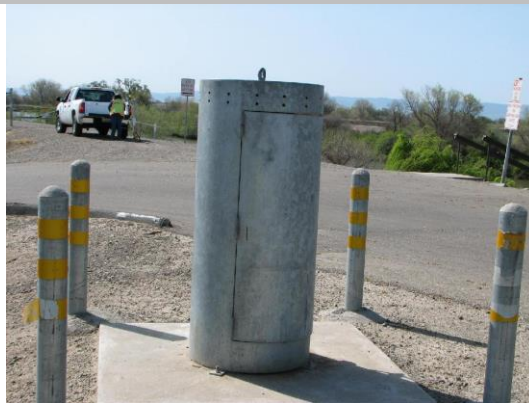
Photo 2 of 3 : UCIP\_SP\_2017\_40682\_72321.jpg

Relief valve located on landward shoulder.

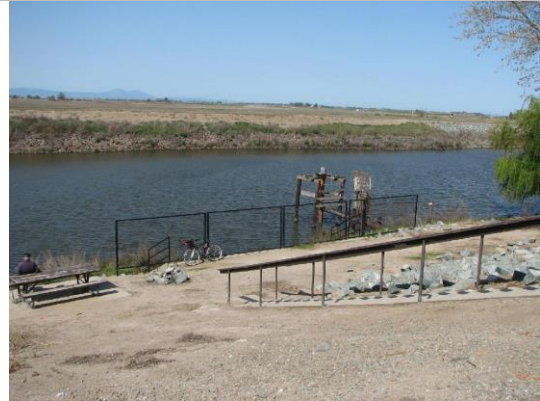
Photo 3 of 3 : UCIP\_SP\_2017\_40682\_72320.jpg

View of waterward side.

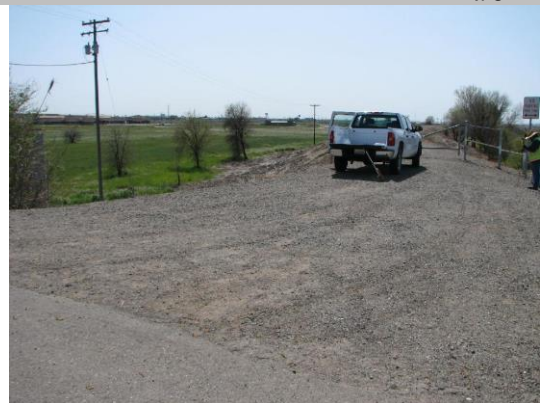
Photo 1 of 3 : UCIP\_SP\_2017\_40683\_72333.jpg

LM Start	7.45	Rating **	M	Issue No.	117
LM End	7.45	Issue Type +	En	Location *	LS
Category	Supplemental			GPS Latitude/Longitude	
				Start	End
Item	DWR UCIP Field Study			37.829922 °	37.829922 °
				-121.310865 °	-121.310865 °
DWR ID					
Comment Code					
Inspector Comment					
FS_ID:40683 DS_ID:284 EP_NO: 15079 Repair Type: Non-Urgent Crossing Status: Found UCIP Comments: Potential leak at standpipe--unable to confirm if crossing is operable. If crossing is no longer in use owner will need to coordinate with DWR inspector and CVFPB to remove according to Title 23 requirements. Unable to determine if crossing is in use. FIELD_STRUCT_DESC: 2 of 2. 10 inch pipe also referenced as 478+22, old 6 inch pipe was removed per encroachment recordation. FS Date: 2/4/2010

Overview of levee crown at crossing.

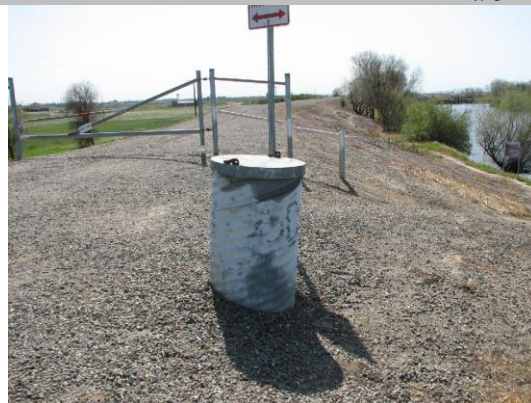
Photo 2 of 3 : UCIP\_SP\_2017\_40683\_72332.jpg

CMP riser located on waterward shoulder.

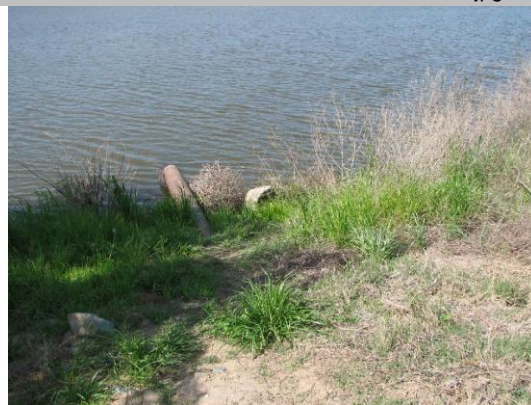
Photo 3 of 3 : UCIP\_SP\_2017\_40683\_72335.jpg

Pipe visible on waterward side.

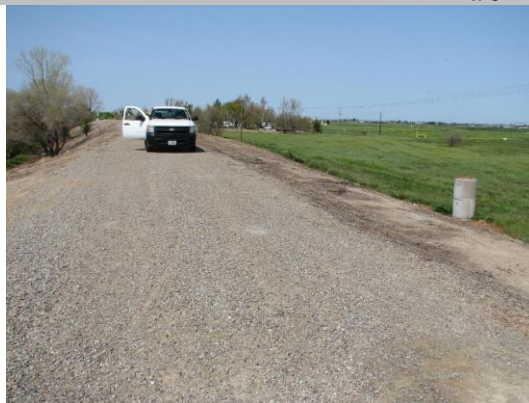
Photo 1 of 3 : UCIP\_SP\_2017\_40684\_72340.jpg

LM Start	7.57	Rating **	M	Issue No.	118
LM End	7.57	Issue Type +	En	Location *	LS
Category	Supplemental			GPS Latitude/Longitude	
				Start	End
Item	DWR UCIP Field Study			37.828258 °	37.828258 °
				-121.310003 °	-121.310003 °
DWR ID					
Comment Code					
Inspector Comment					
FS_ID:40684 DS_ID:97 EP_NO: 15080 Repair Type: Non-Urgent Crossing Status: Found UCIP Comments: Pipe appears no longer in use. If crossing is no longer in use owner will need to coordinate with DWR inspector and CVFPB to remove according to Title 23 requirements. Unable to determine if crossing is in use. FIELD_STRUCT_DESC: 6 inch steel irrigation pipe through the levee at 4.43-feet below crown. Pump on WS slope, siphon breaker on WS shoulder, and standpipe on LS toe (Permit No. 15080-1989). FS Date: 2/4/2010

Overview of levee crown at crossing.

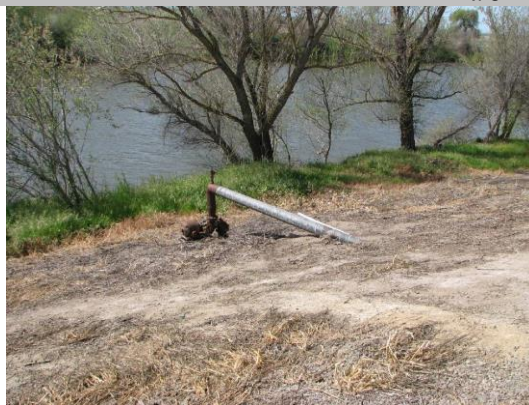
Photo 2 of 3 : UCIP\_SP\_2017\_40684\_72342.jpg

View of waterward side.

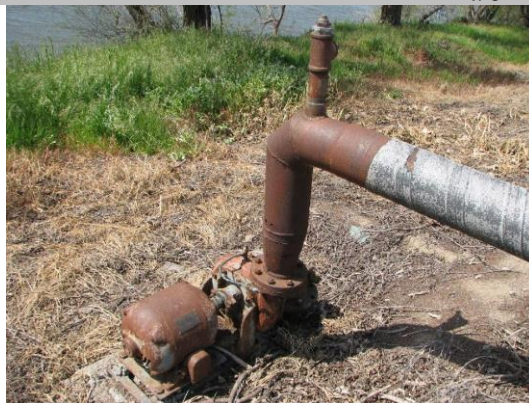
Photo 3 of 3 : UCIP\_SP\_2017\_40684\_72338.jpg

LM Start	7.57	Rating **	M	Issue No.	118 (cont)	
LM End	7.57	Issue Type +	En	Location *	LS	
Category	Supplemental			GPS Latitude/Longitude		
				Start	End	
Item	DWR UCIP Field Study			37.828258 °	37.828258 °	
				-121.310003 °	-121.310003 °	
DWR ID						
Comment Code						
Inspector Comment						
FS_ID:40684						
DS_ID:97						
EP_NO: 15080						
Repair Type: Non-Urgent						
Crossing Status: Found						
UCIP Comments: Pipe appears no longer in use. If crossing is no longer in use owner will need to coordinate with DWR inspector and CVFPB to remove according to Title 23 requirements. Unable to determine if crossing is in use.						
FIELD_STRUCT_DESC: 6 inch steel irrigation pipe through the levee at 4.43-feet below crown. Pump on WS slope, siphon breaker on WS shoulder, and standpipe on LS toe (Permit No. 15080-1989).						
FS Date: 2/4/2010

Pump and pipe located on waterward slope.

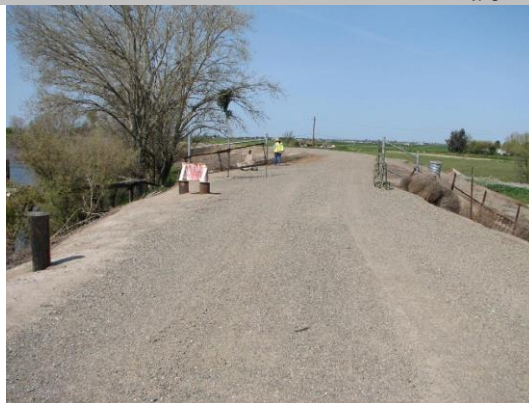
Photo 1 of 3 : UCIP\_SP\_2017\_40685\_72351.jpg

LM Start	7.71	Rating **	M	Issue No.	119
LM End	7.71	Issue Type +	En	Location *	LS
Category	Supplemental			GPS Latitude/Longitude	
				Start	End
Item	DWR UCIP Field Study			37.826333 °	37.826333 °
				-121.309495 °	-121.309495 °
DWR ID					
Comment Code					
Inspector Comment					
FS_ID:40685 DS_ID:98 EP_NO: 15081 Repair Type: Non-Urgent Crossing Status: Found UCIP Comments: Erosion present on waterward toe underneath piles. Need to coordinate with owner to address issue on waterward side and to determine status of crossing. FIELD_STRUCT_DESC: 16 inch diameter asphalt coated and wrapped steel irrigaiton pipe through the levee 2.6-feet below the crown. Siphon breaker located on landward side. Stand pipe located at landward toe. Pump on Platform at WS toe Permit No. 15081, 1989. FS Date: 2/4/2010

Overview of levee crown at pipe crossing.

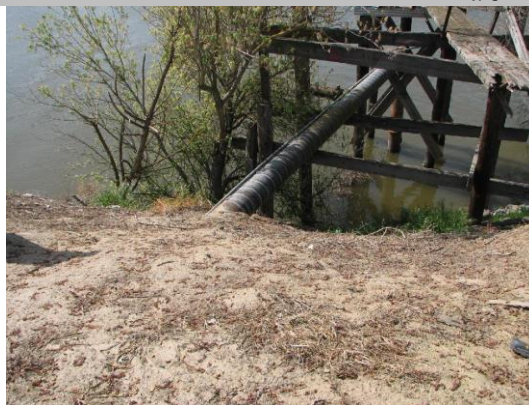
Photo 2 of 3 : UCIP\_SP\_2017\_40685\_72350.jpg

Pipe daylight on waterward side.

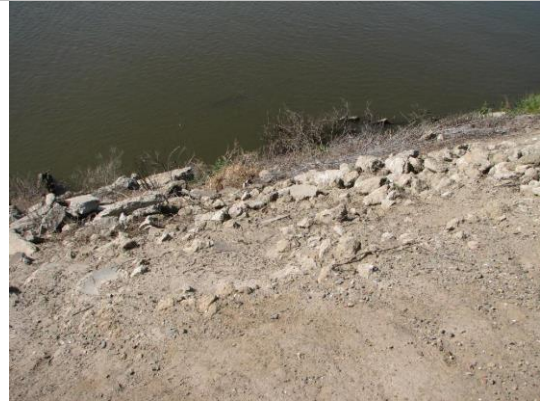
Photo 2 of 2 : UCIP\_SP\_2017\_40686\_72352.jpg

LM Start	7.73	Rating **	M	Issue No.	120 (cont)	
LM End	7.73	Issue Type +	En	Location *	LS	
Category	Supplemental			GPS Latitude/Longitude		
				Start	End	
Item	DWR UCIP Field Study			37.826031 °	37.826031 °	
				-121.309569 °	-121.309569 °	
DWR ID						
Comment Code						
Inspector Comment						
FS_ID:40686						
DS_ID:804						
EP_NO: N/A						
Repair Type: Non-Urgent						
Crossing Status: Indicator Found						
UCIP Comments: Unable to find any appurtenances need to coordinate with owner to obtain additional information about crossing. Standpipe appears abandoned. If crossing is no longer in use owner will need to coordinate with DWR inspector and CVFPB to remove according to Title 23 requirements. Unable to determine if crossing is in use.						
FIELD_STRUCT_DESC: Standpipe located on levee crown.						
FS Date: 2/4/2010

View of waterward side.

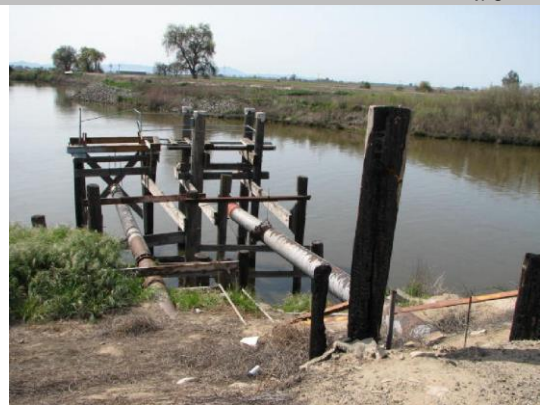
Photo 1 of 3 : UCIP\_SP\_2017\_40687\_72357.jpg

Comment Code					
Inspector Comment					
FS_ID:40687 DS_ID:100 EP_NO: 15082 Repair Type: Non-Urgent Crossing Status: Found UCIP Comments: Pumps were removed and no power connection visible. Crossing appears abandoned. If crossing is no longer in use owner will need to coordinate with DWR inspector and CVFPB to remove according to Title 23 requirements. Unable to determine if crossing is in use. FIELD_STRUCT_DESC: 1 of 2. 20 inch asphalt coated and wrapped steel irrigation pipe through levee 2.1-feet below the crown. Pump missing from platform on waterward side. Siphon breaker inside 24-inch CMP riser on LS shoulder (Permit No. 15082, 1982). FS Date: 2/4/2010

View of waterward side.

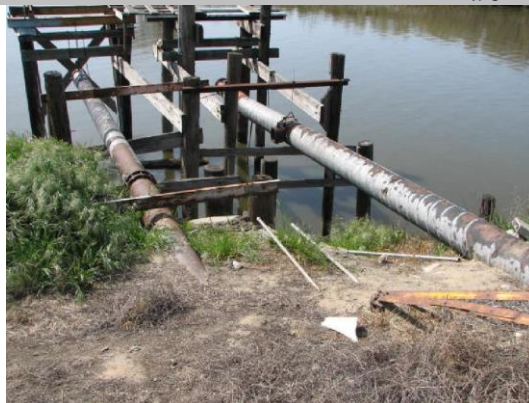
Photo 2 of 3 : UCIP\_SP\_2017\_40687\_72356.jpg

View of waterward side--no pumps present anymore.

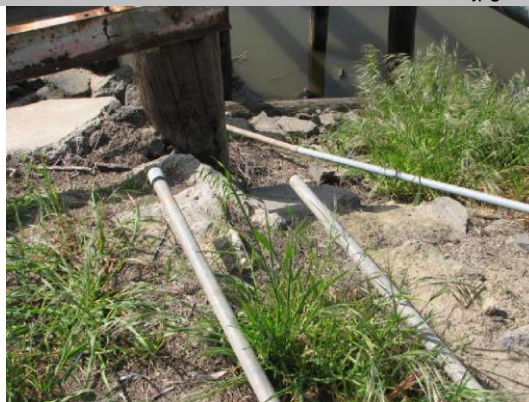
Photo 3 of 3 : UCIP\_SP\_2017\_40687\_72358.jpg

Conduit lines present on waterward side--no connection.

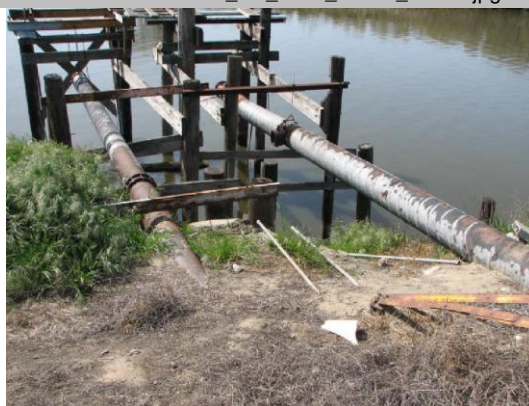
Photo 1 of 3 : UCIP\_SP\_2017\_40688\_72361.jpg

Comment Code					
Inspector Comment					
FS_ID:40688					
DS_ID:288					
EP_NO: 15082					
Repair Type: Non-Urgent					
Crossing Status: Found					
UCIP Comments: Pump was removed and no power connection visible.					
Crossing appears abandoned. If crossing is no longer in use owner will					
need to coordinate with DWR inspector and CVFPB to remove					
according to Title 23 requirements. Unable to determine if crossing is in					
use.					
FIELD_STRUCT_DESC: 2 of 2. 16- inch asphalt coated and wrapped					
steel irrigation pipe through levee 2.6-feet below the crown. Pump					
missing from platform on waterward side. Siphon breaker inside 24-inch					
CMP riser on LS shoulder. 1.5-inch galvanized iron electrical conduit at					
same location (Permit No. 15082, 1982).					
FS Date: 2/4/2010

View of pipe on waterward side.

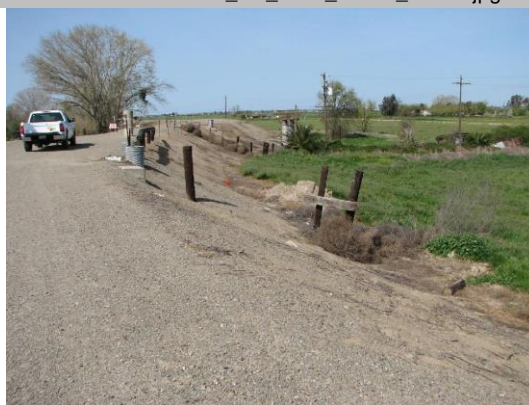
Photo 2 of 3 : UCIP\_SP\_2017\_40688\_72360.jpg

View of landward side.

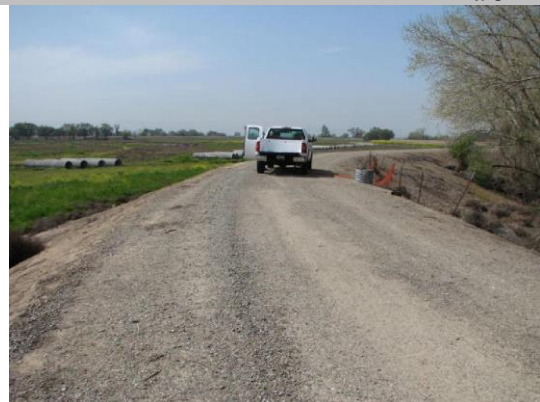
Photo 1 of 3 : UCIP\_SP\_2017\_40689\_72367.jpg

LM Start	7.89	Rating **	M	Issue No.	123
LM End	7.89	Issue Type +	En	Location *	LS
Category	Supplemental			GPS Latitude/Longitude	
				Start	End
Item	DWR UCIP Field Study			37.823987 °	37.823987 °
				-121.309841 °	-121.309841 °
DWR ID					
Comment Code					
Inspector Comment					
FS_ID:40689					
DS_ID:805					
EP_NO: N/A					
Repair Type: Non-Urgent					
Crossing Status: Indicator Found					
UCIP Comments: Only siphon breakers were found on landward shoulder no other appurtenances were found. If crossing is no longer in use owner will need to coordinate with DWR inspector and CVFPB to remove according to Title 23 requirements. Unable to determine if crossing is in use.					
FIELD_STRUCT_DESC: Siphon breaker located on landward shoulder.					
FS Date: 2/4/2010

View of levee crown at crossing.

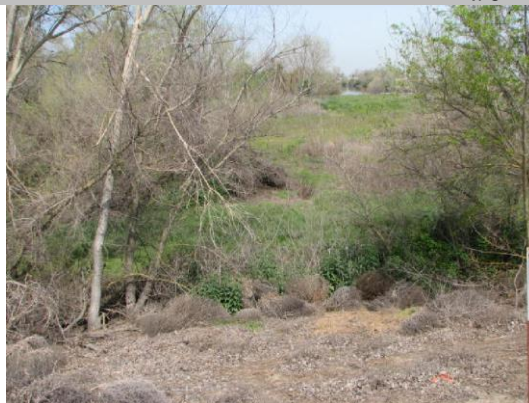
Photo 2 of 3 : UCIP\_SP\_2017\_40689\_72366.jpg

View of landward side.

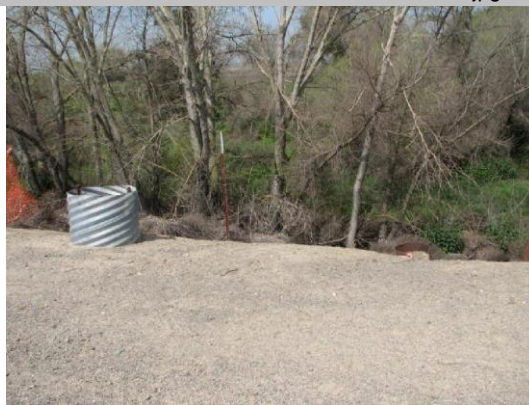
Photo 3 of 3 : UCIP\_SP\_2017\_40689\_72369.jpg

CMP riser located on landward side.

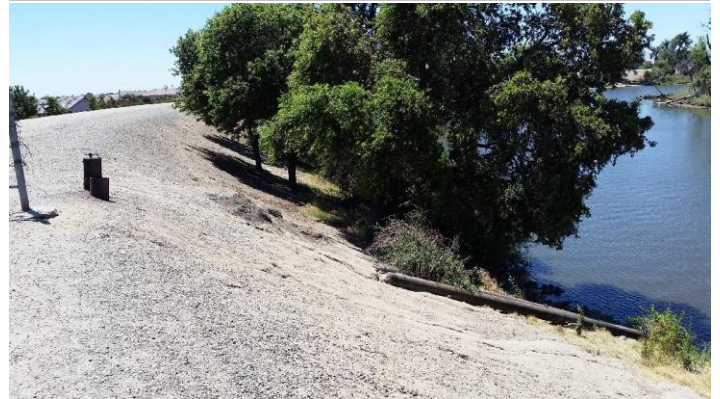
Photo 1 of 3 : UCIP\_SP\_2017\_49999\_75741.jpg

FS\_ID:49999  
DS\_ID:285  
EP\_NO: 15083  
Repair Type: Urgent  
Crossing Status: Found  
UCIP Comments: 7/12/2016 Same as last inspection--WS pipe section deteriorated. Per Rick Toy, KSN-District Engineer, this crossing is currently owned by the City of Lathrop. Need to coordinate with the City of Lathrop to submit name change to the CVFPB and for the City to provide future use for this crossing. Recommend internal integrity inspection of section of the pipe through the levee. (DWR UCIP - omagana)5/21/2015 Pipe is still in same condition. Need to contact KSN, LMA engineering firm, to determine update on crossing. (DWR UCIP - omagana)2/04/2010 Pipe wall has corroded through--wall missing from pipe section located on waterward side. Recommend investigating the pipe integrity through levee section. Damage to pipe has eroded the levee slope on waterward side. Recommend LMA superintendent contact owner to stop using crossing and coordinate with CVFPB to address pipe leak. Owner will need to coordinate with DWR inspector and CVFPB. (DWR UCIP - omagana)

View of WS.

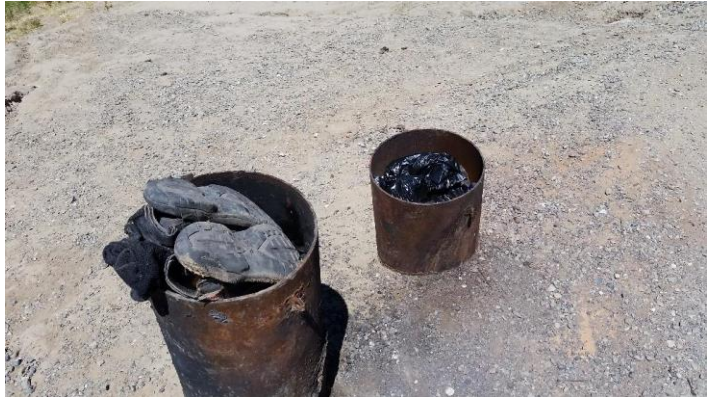
Photo 3 of 3 : UCIP\_SP\_2017\_49999\_75738.jpg

FS\_ID:49999  
DS\_ID:285  
EP\_NO: 15083  
Repair Type: Urgent  
Crossing Status: Found  
UCIP Comments: 7/12/2016 Same as last inspection--WS pipe section deteriorated. Per Rick Toy, KSN-District Engineer, this crossing is currently owned by the City of Lathrop. Need to coordinate with the City of Lathrop to submit name change to the CVFPB and for the City to provide future use for this crossing. Recommend internal integrity inspection of section of the pipe through the levee. (DWR UCIP - omagana)5/21/2015 Pipe is still in same condition. Need to contact KSN, LMA engineering firm, to determine update on crossing. (DWR UCIP - omagana)2/04/2010 Pipe wall has corroded through--wall missing from pipe section located on waterward side. Recommend investigating the pipe integrity through levee section. Damage to pipe has eroded the levee slope on waterward side. Recommend LMA superintendent contact owner to stop using crossing and coordinate with CVFPB to address pipe leak. Owner will need to coordinate with DWR inspector and CVFPB. (DWR UCIP - omagana)

WS shoulder--protective housing units for siphon breakers.

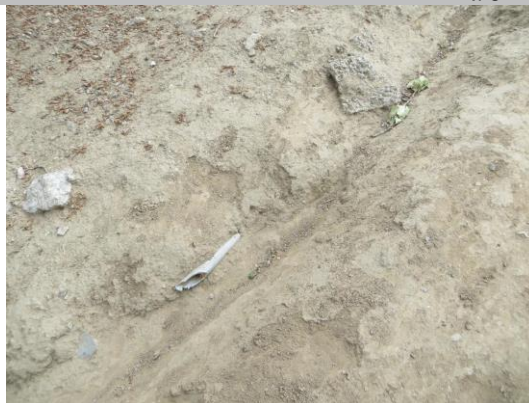
Photo 1 of 2 : UCIP\_SP\_2017\_45453\_74112.jpg

Comment Code					
Inspector Comment					
FS_ID:45453 DS_ID:48 EP_NO: 15084 Repair Type: Non-Urgent Crossing Status: Indicator Found UCIP Comments: Need to contact owner to determine disposition of pipe. No record of removal has been found and status of crossing needs to be determined. FIELD_STRUCT_DESC: 8 inch diameter pipe through levee. Invert of pipe is 3.47 feet below levee crown. (Siphon breaker on landward shoulder. Slant pump on waterward slope, concrete stairway from pump to waterward shoulder, standpipe located 20 feet from the landward toe): Not found. Only indicator is a 1.5-inch PVC electrical conduit visible on WS slope 6-feet below the crown. (Permit No. 15084-1989) FS Date: 5/21/2015

Electrical conduit only appurtanance found on WS slope.
